FINAL REPORT  
MAY 1995

REPORT NO. 94-26

ENHANCED WOOD PALLET  
EVALUATION

VALIDATION ENGINEERING DIVISION  
SAVANNA, ILLINOIS 61074-9639

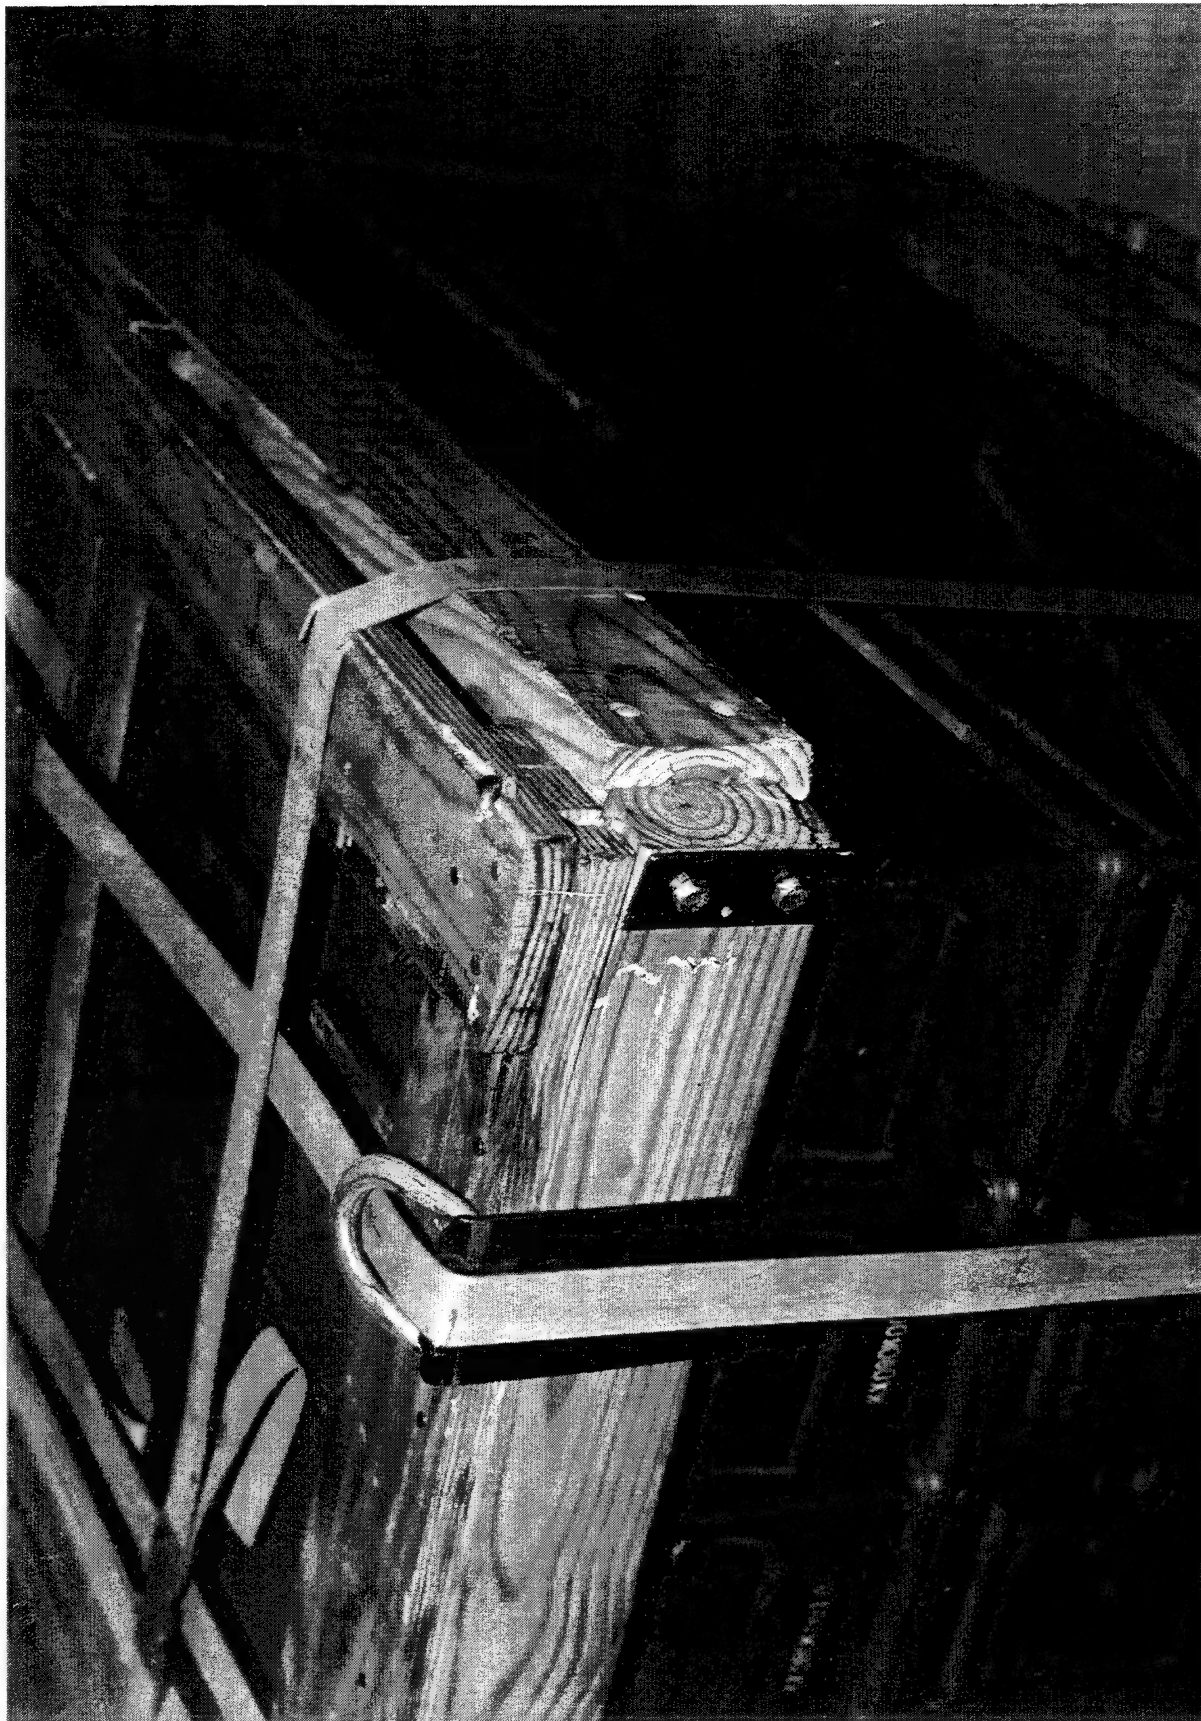
PHOTO NO. SCN94-223-4455. This photo shows a closeup view of additional damage which occurred during rail testing.

- a. The skids on the 120mm ammunition pallets rode up and under the forklift tine protector (2- by 4-inch timber) of the adjacent pallets.
- b. The vertical center gate on the 40mm ammunition side of the railcar failed.
- c. The 40mm ammunition side of the railcar top pallet adapter 2- by 4-inch timber failed due to misalignment of the adjacent pallet.
- d. Many pallet adapter boards showed cracking in and around nail holes.

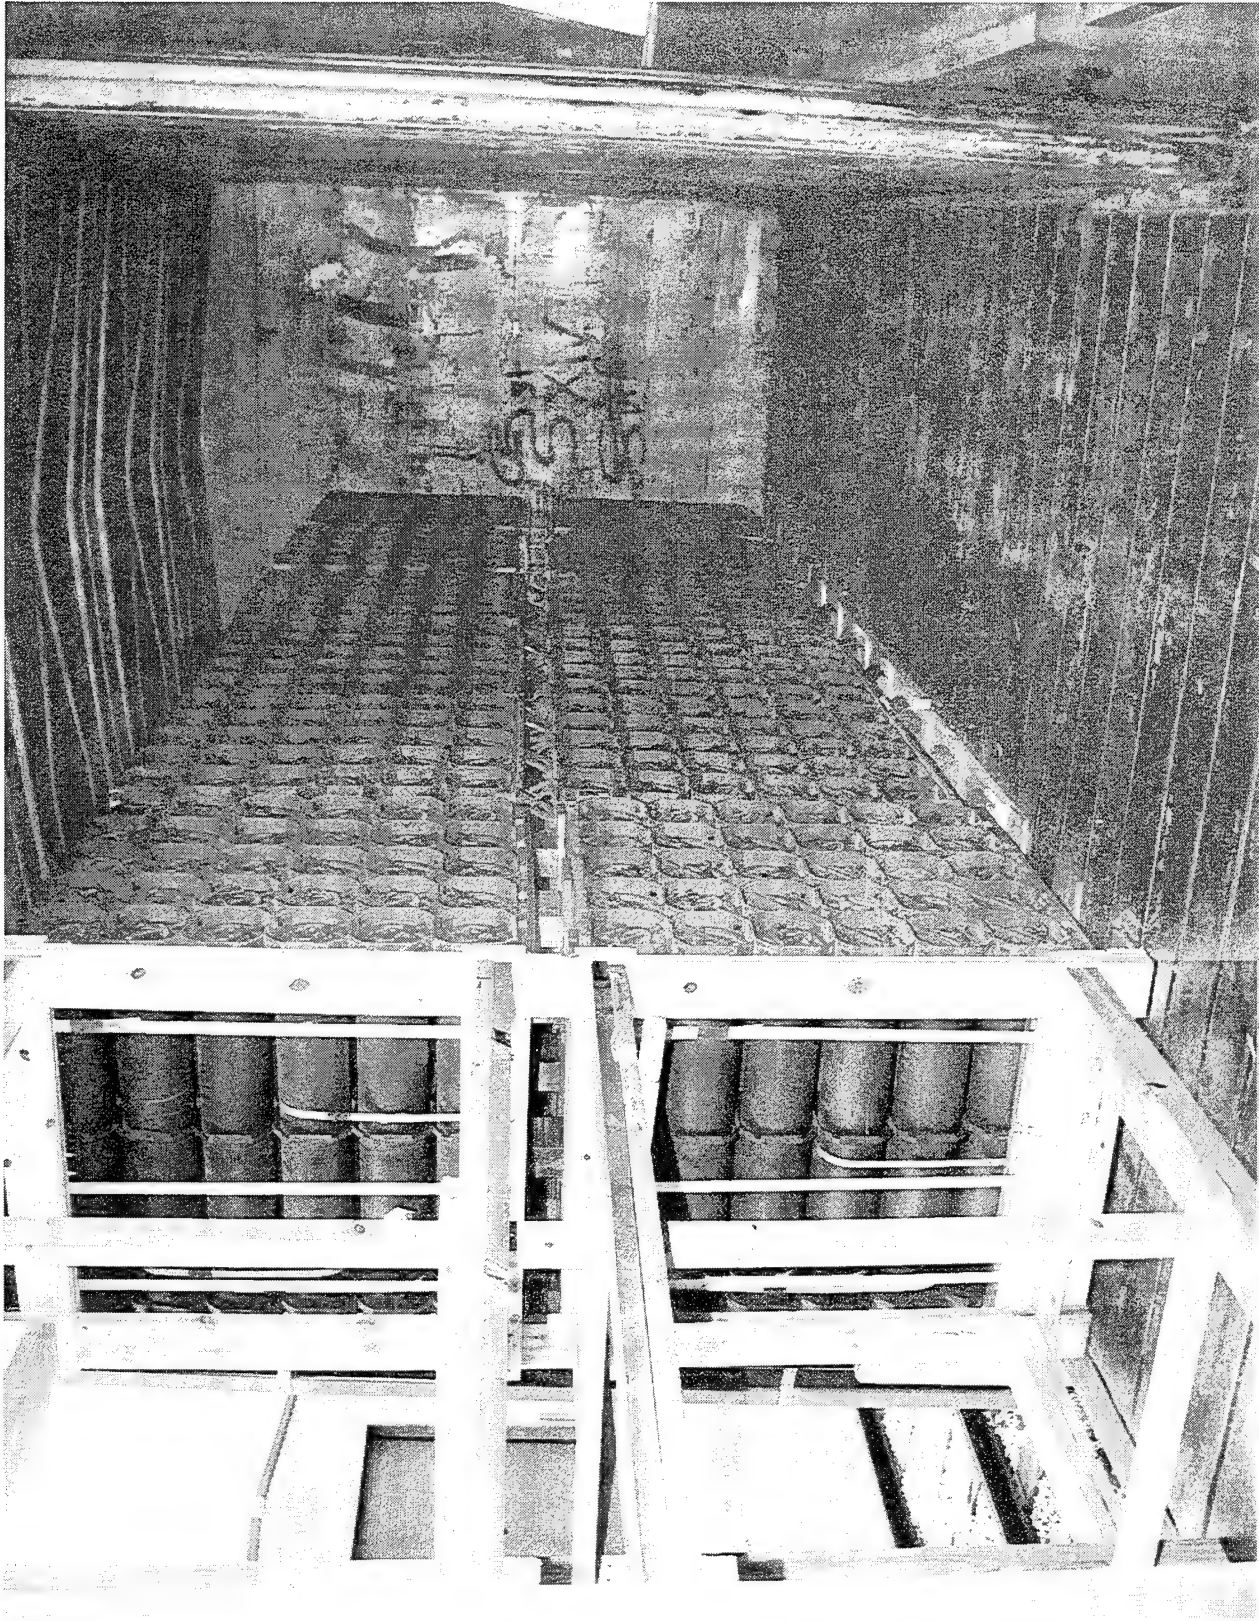
PHOTO NO. SCN94-222-4168. This photo shows an overall view of the 120MM ammunition pallet loaded in the boxcar prior to testing.

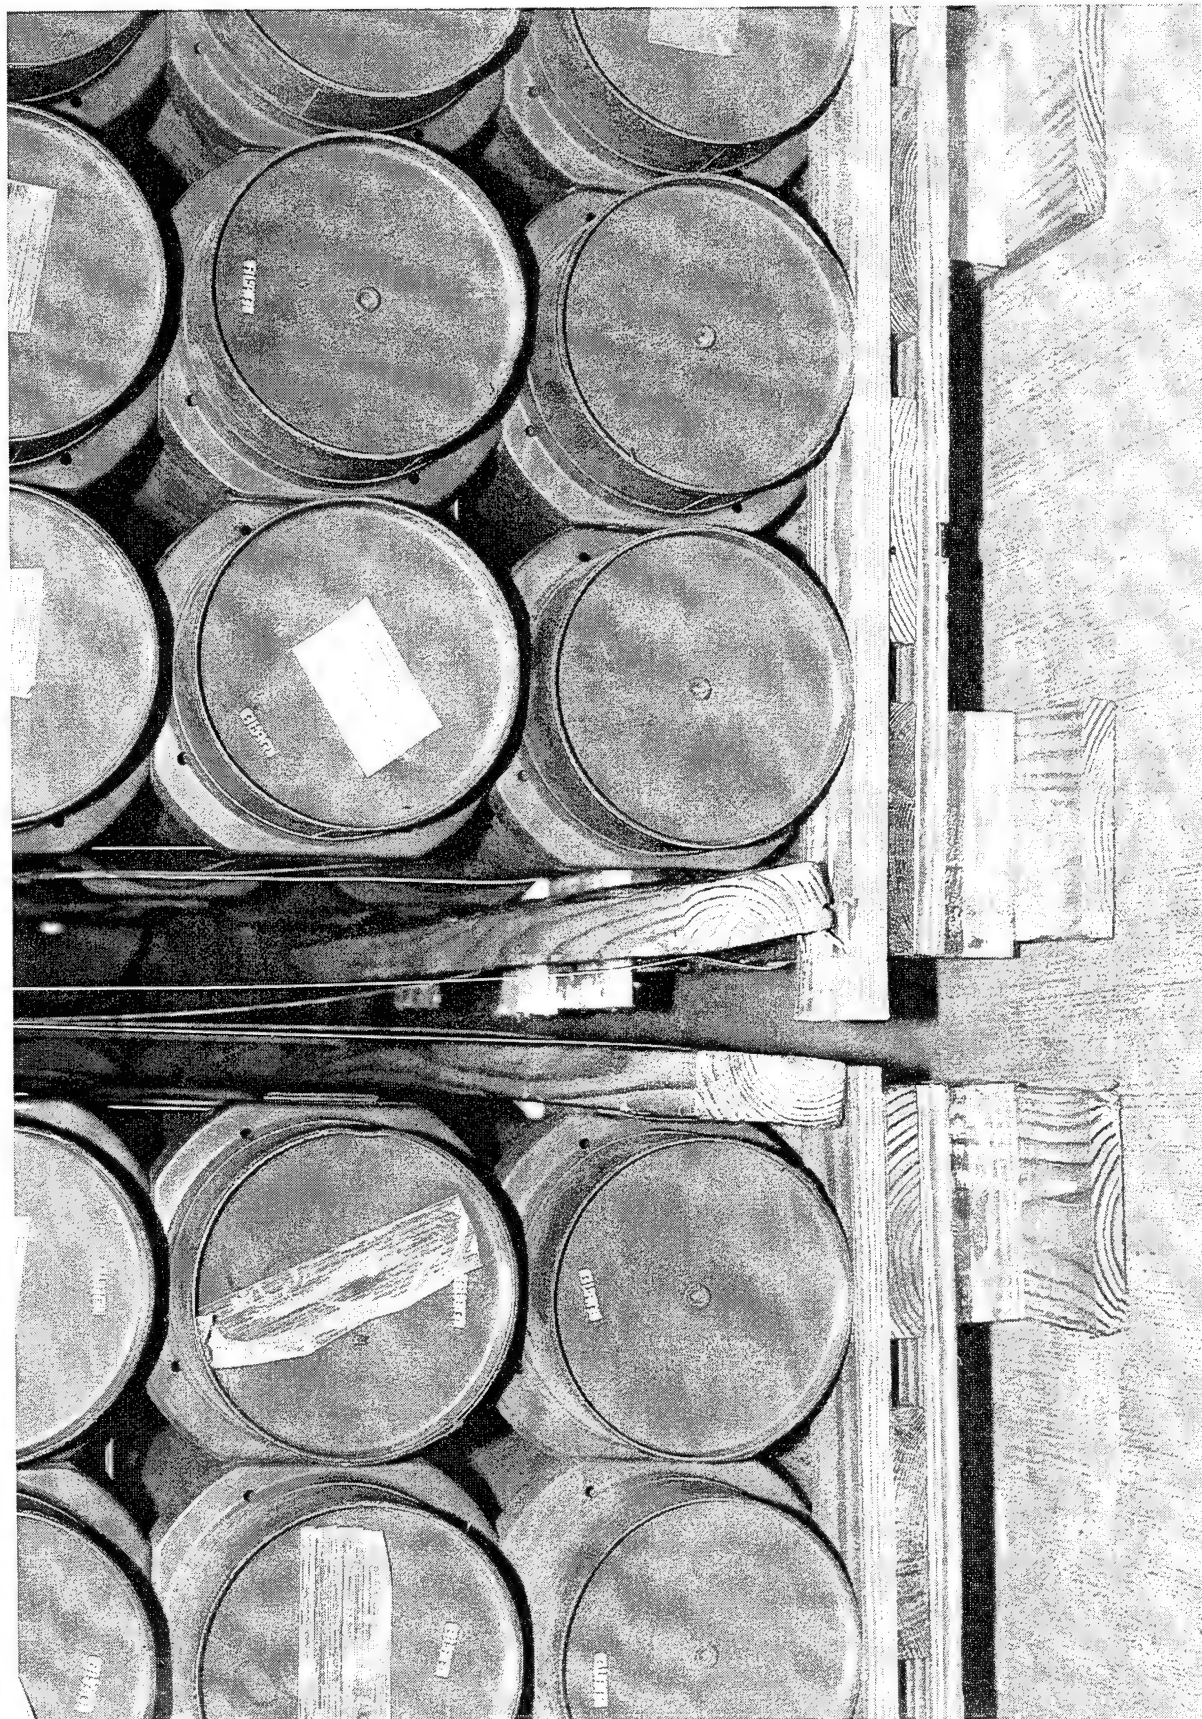
PHOTO NO. SCN94-223-4452. This photo shows the lower pallet adapter damage following rail impact testing.

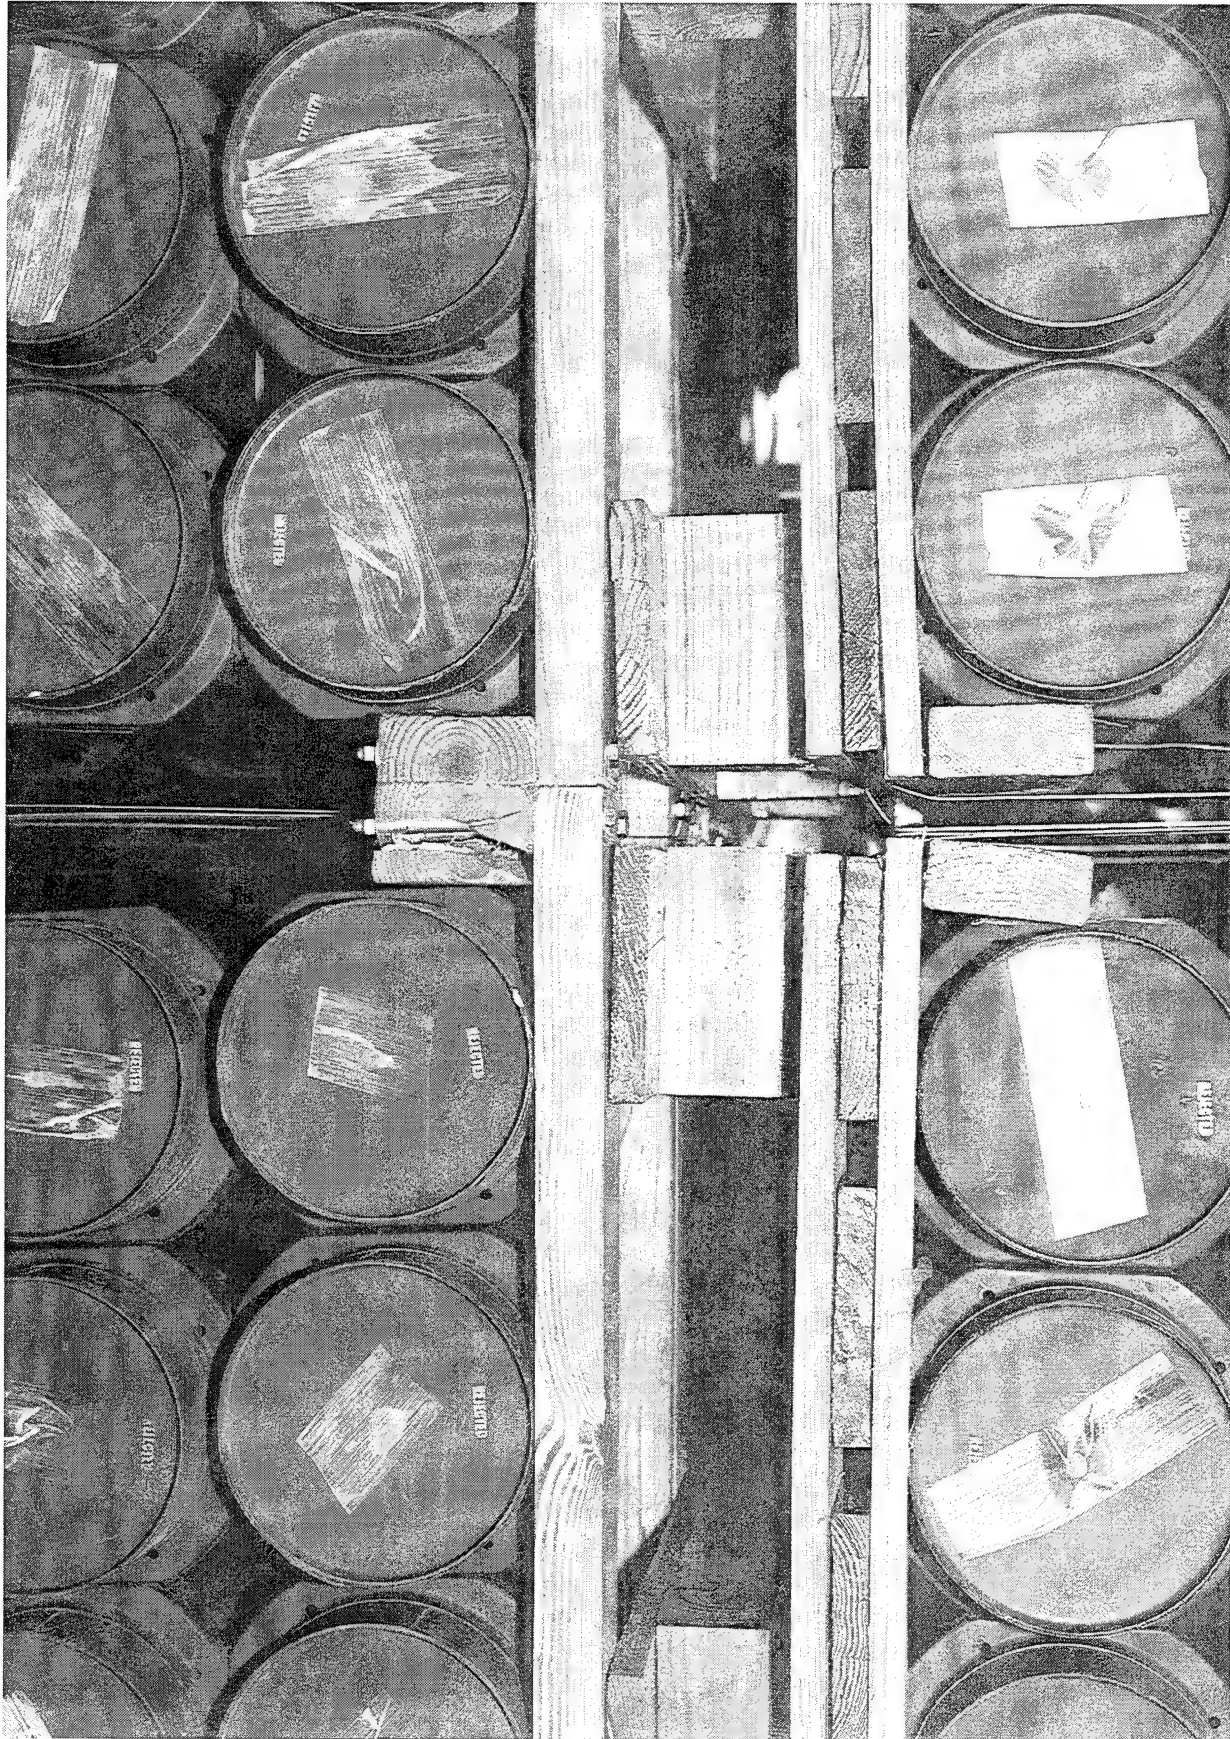
PHOTO NO. SCN94-223-4456. This photo shows the damage received to the top pallet adapter following rail impact testing. Note the bolt being pulled out of the 2- by 4-inch dimensional lumber.
